# Manhole Inspection Summary

# Manhole # S55U\_\_006MH

Insp Date: **7/9/08 11:18 AM**

**Location** Address: **1701 s. clinton st.**

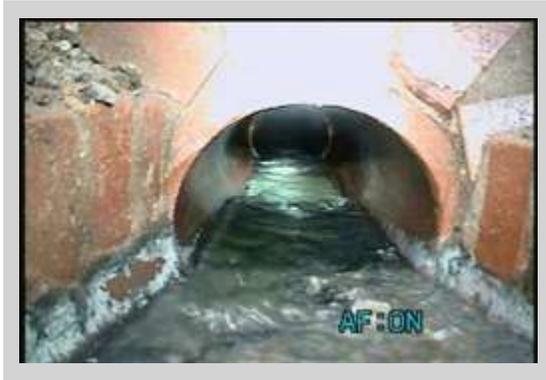
12 O'Clock Outflow

8 in. Circular Gravity Sewer  
Pipe Out @ 12 O'Clock

Pipe Material: **Clay**  Pipe Lined

Invert Depth: **9.03** (ft.) Flow Characteristics: **Fast**

Infiltration: **None** Pipe Seal Cond: **Unknown**

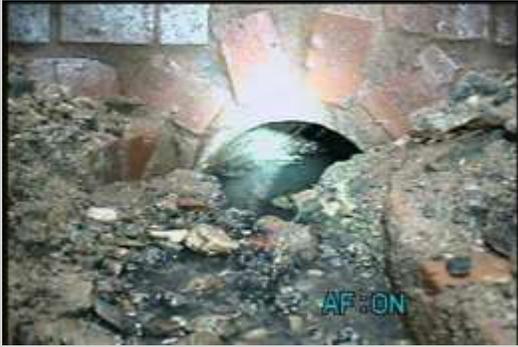
9 O'Clock Inflow

8 in. Circular Gravity Sewer

Pipe In @ 9 O'Clock

Pipe Material: **Clay**  Pipe Lined

Infiltration: **None** Pipe Seal Cond: **Unknown**
